Victor Division  
**RCA Victor Company, Inc.**  
 Camden, N. J.

**Service Bulletin No. 24-C**

**NEW TYPE AUTOMATIC VICTROLA AND  
 ELECTROLA**

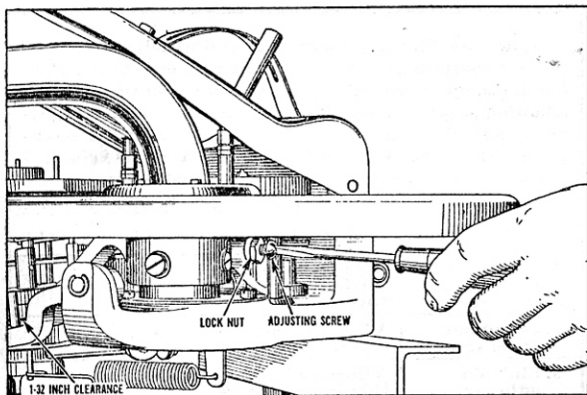
Fig. 2—Adjusting Sound Box Lift Lever

**1. FAILURE OF NEEDLE TO SWING INTO FIRST RECORD GROOVE**—If the needle fails to swing into the first record groove after striking the smooth outside rim:

- a. Determine if the instrument is level by placing a spirit level on the turntable.
- b. If the right side of the cabinet is low, raise this side slightly by placing a thin wooden wedge or other available material under the feet of the lower end.
- c. If the condition is not corrected by the above adjustment:

Loosen the lock nut and adjust the sound box lift lever adjusting screw as shown in Fig. 2 until there is a clearance of approximately  $\frac{1}{32}$ " between the under side of the taper tube arm casting and the top of the sound box lift lever as shown. This clearance can be checked by placing a thin piece of cardboard between the two points and observing whether or not there is a dragging on the cardboard when the tone arm is moved toward the center of the record. *This clearance is highly important and will affect other conditions of the mechanism if not properly adjusted.*

**2. EXCESSIVE WEAR ON RECORDS**—If excessive wear on the records is noted, the same adjustments as described in subject 1 above should be made. It may be possible that the needle will move into the record groove after striking the smooth outside rim, but will cause excessive wear on the record due to a slight contact between the two points shown in Fig. 2 where the  $\frac{1}{32}$ " clearance should exist.

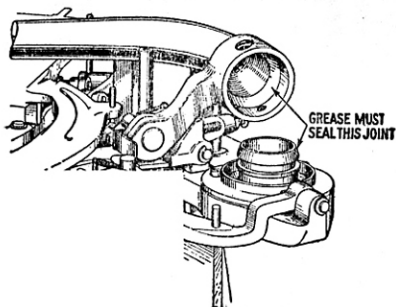
Fig. 19—Tone Arm Removed, Showing Grease Seal

**27. POOR TONE QUALITY IN 10-35 AUTOMATIC ORTHOPHONIC VICTROLA**—If the tone quality of the Automatic Orthophonic Victrola instrument is not up to standard:

- a. Replace sound box, bearing in mind if this is done that it may be necessary to re-adjust the tone arm as described in subject 3 above.
- b. If replacing the sound box does not correct the quality, it is possible that there is an air leak in the sound system between the end of the tone arm and the horn.

- c. Remove the sound box from the tone arm. Blow smoke lightly into the tube, taking care not to use too great force since the grease seal around the joint at the base of the tone arm may otherwise become broken. Smoke can be seen escaping where the leak exists.

- d. If the above tests show an air leak at the joint between the sound box crook and the tone arm:
  1. Remove the crook, and distribute firm cup grease around the joints in the sleeve inside the tone arm.

2. Replace the crook, again test for air leaks.
- e. If the leak has been found to exist in the joint at the base of the tone arm:
  1. Remove the tone arm by taking out the three screws.

2. Remove the spring 39, Fig. 1.
  3. Distribute firm cup grease around the two surfaces as shown in Fig. 19.
  4. Replace the tone arm, and again test for air leaks.

*NOTE—Victor motor grease should not be used to seal joints as described above since this grease is too light for the purpose.*

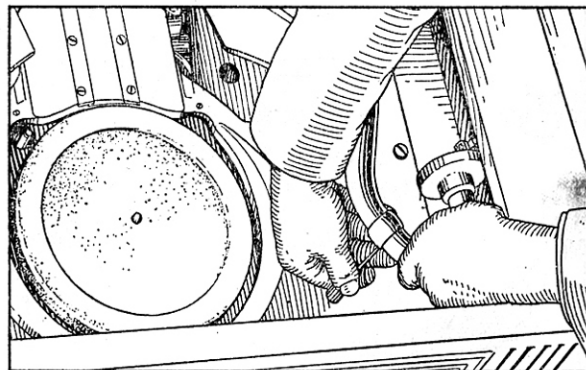
Fig. 3—Adjusting Crook Stop

**3. NEEDLE DOES NOT LOWER SUFFICIENTLY**—When the  $\frac{1}{2}$ " clearance described in c of subject 1 above is obtained, the clearance between the needle point and the record should be approximately  $\frac{3}{8}$ " on the return of the tone arm. If this clearance does not exist:

- a. Examine the position of the tone arm cover plate. It should be so placed on the motor board that the tone arm does not touch the plate at any time. The screws in the plate can be loosened if necessary, care being taken not to turn these so far that the nuts on the bottom are dropped, and the plate then moved slightly to allow clearance of the tone arm. Re-tighten the screws securely when the proper clearance has been obtained.
- b. Examine the sound box or pickup crook stop. Loosen the lock nuts and turn the stop screw, which is an eccentric, until the proper lowering has been obtained. Re-tighten the lock nut when the proper lowering has been obtained. See Fig. 3.

**4. NEEDLE DOES NOT CLEAR RECORD**—If the tone arm does not rise sufficiently for the needle to clear the record on the return of the tone arm:

- a. Examine the position of the tone arm cover plate and the crook stop making the same adjustments as described in subject 3 above except that the eccentric screw must be turned in the opposite direction.
- b. If the condition is still not corrected, particularly if there seems to be a sluggish action of the return of the tone arm, remove the sound box lift lever spring shown in Fig. 2, and increase its tension by shortening the straight section of the spring, bending it nearer the coiled section.

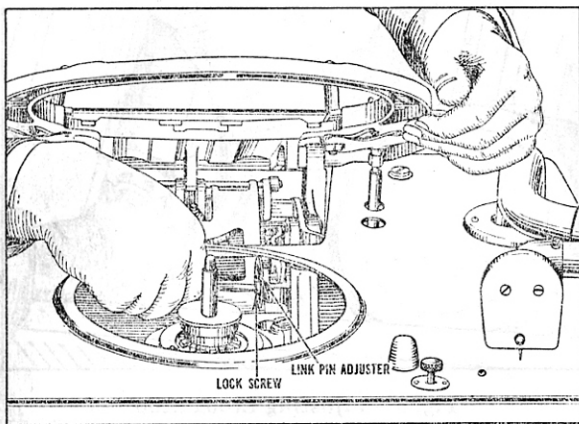
Fig. 4—Adjusting Link Pin Adjuster

**5. LIFT RING DROPS SLIGHTLY WHEN DESCENDING**—If the lift ring suddenly drops about  $\frac{1}{4}$ " when first starting down, make the following adjustments:

- a. Remove the turntable.
- b. Loosen the lock screw in the link pin adjuster as shown in Fig. 4.
- c. Turn the mechanism until the main slide is in its extreme forward position.
- d. Turn the link pin adjuster until the rollers of the lift lever mechanism 48, Fig. 1, are in the slots pressing against the extreme end of their track (cam).

*NOTE—Do not advance the adjuster so far that the rollers are too tight against the end of the cam since there will be a strain and possible binding of the entire mechanism.*

- e. Re-tighten the lock screw.

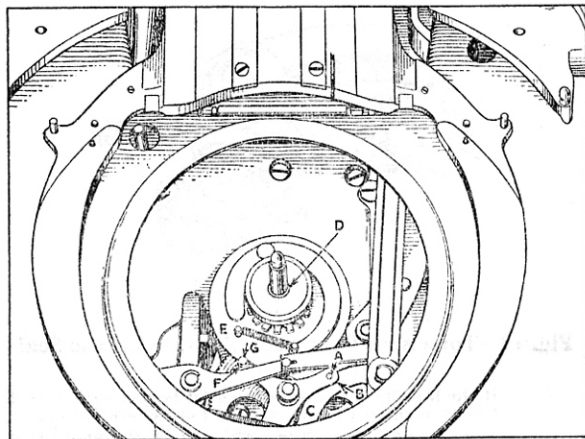
Fig. 18—Method of Timing Gears

**26. TIMING MECHANISM—**  
**When the motor or any of the gears have been removed, it will be necessary to re-time the mechanism in the following manner:**

- a. Remove the turntable.
- b. Turn the mechanism by hand until the roller A, Fig. 18, is engaged in the slot B of the cam gear C.
- c. Loosen the set screw in the clutch wheel D, lift the wheel, the pawl and pawl carrier E, and turn the latter until the roller F is in line with the slot G.
- d. Lower the pawl and pawl carrier and the clutch wheel, and then re-tighten the set screw, aligning the screw with the spot in the motor spindle.

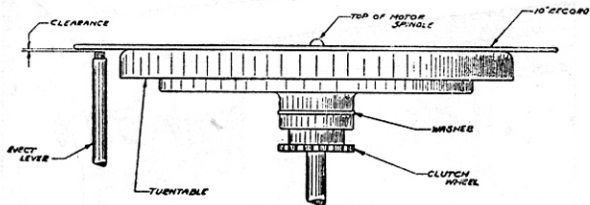
**Fig. 17—Correct Height of Record on Turntable Spindle**

**21. SLUGGISH ACTION OF EJECT MECHANISM OR RECORD EJECTS TOWARD FRONT OF CABINET**—If the record is not entirely ejected from the turntable before the lift ring starts to rise, or if a record is ejected toward the front of the cabinet rather than in the discharge compartment:

- a. Note the height of the record on the motor spindle, and compare this height with the correct height as shown in Fig. 17. If the record is considerably lower, raise the height by placing one or more cork or fibre washers, part 51870, under the turntable.
- b. Examine the leather on the end of the eject lever. If this is worn smooth, roughen it by scraping with a sharp knife or file.

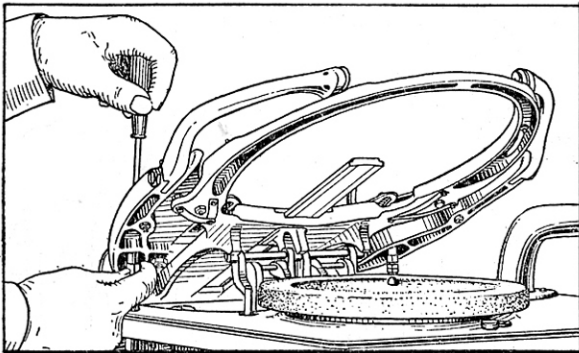
**Fig. 6—Adjusting Height of Hopper**

**6. LIFT RING FAILS TO REMOVE RECORD—**  
If the lift ring fails to remove a record,

1. Loosen the hopper support screws as shown in Fig. 6.
2. With the lift ring in its highest position, turn the hopper adjusting nuts so that the top surface of the hopper is exactly flush with the top of the lift ring. A straight edge can be used as a gauge for this height. It should be placed across the two surfaces as shown in Fig. 7. This same method should then be used for gauging the height on the opposite side of the hopper. Turn the hopper support screws so that there can be an additional upward movement of the hopper of approximately  $\frac{1}{8}$ " on each side with the hopper resting on each top adjusting nut. This amount of play will prevent any possible binding of the lift ring and hopper. Adjust the lift ring screws as shown in Fig. 8, until the ends touch the under side of the hopper when the ring is in its highest position.

3. Note the action of the knives on the record support pins. The height of these should be tested by means of the gauges 52467, 52468 and 52855. Pushing the top of the record support pins down, insert the .065"—.070" gauge, Part 53370, under each knife. This adjustment should be made when lift ring is up and knives turned inward. If the knife is too high or too low, it should be bent slightly by prying with a screw driver until the proper height is obtained. Part 52855 can be used to obtain the proper angularity as well as the .120" height. With the lift ring down, insert the gauge 52855

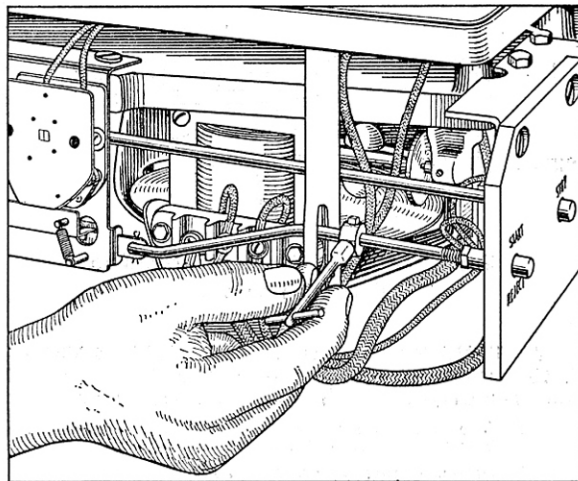
**Fig. 16—Adjusting Reject Collar**

**17. FAILURE TO REJECT RECORD**—If the automatic mechanism does not trip when the "Reject" button is pressed, and the record is therefore not rejected:

- a. Note that the condition is not caused by a wire between the reject rod collar 87, Fig. 12, and the fork portion of the trip lever.
- b. If the condition is not yet corrected, loosen the set screws in the collar as shown in Fig. 16, using a socket wrench such as part 53306, and set the collar approximately  $\frac{1}{8}$ " away from the trip lever. Re-tighten the set screws.

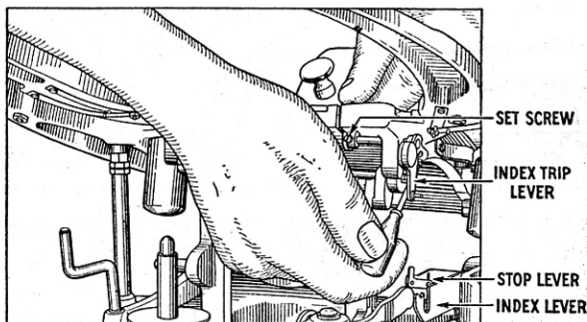
Fig. 15—Adjusting Index Trip Lever

**16. FAILURE TO SELECT 10" AND 12" POSITION**—If the mechanism does not select the 10" and 12" position, that is, if the needle lowers in the 10" position on a 12" record, or on the rubber support block when a 10" record is on the turntable:

- a. Records are improperly loaded in hopper.
- b. Tighten the set screw on the index lever trip cam, shown in Fig. 15, so that it is against the flat of the index trip lever shaft. Loosen the lock nut in the index trip lever as shown in Fig. 15, and adjust the screw until the inside pin lowers on the stop lever and the outside pin lowers in the larger slot of the index lever when the lift ring comes down without a record.
