Victor Division  
**RCA Victor Company, Inc.**  
 Camden, N. J.

**Service Bulletin No. 24-C**

**NEW TYPE AUTOMATIC VICTROLA AND  
 ELECTROLA**

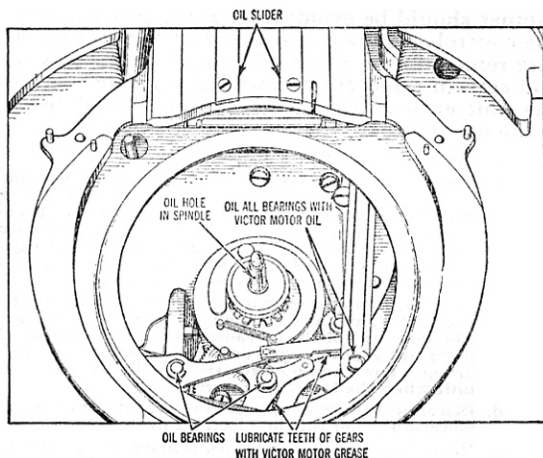
Fig. 20—Oiling Diagram Automatic Mechanism

30. **LUBRICATION**—A hollow motor spindle with openings at the various bearings permits lubrication of these parts as well as the back governor bearing from the oil hole shown in Fig. 20. The front governor bearing, the governor friction sleeve, and friction leather can be lubricated by inserting a long spout oil can down through the hole in the top of the mechanism below the intermediate gear. The mechanism should be oiled at least once a month, and in commercial installations, playing an average of eight hours a day, this period should be reduced to once a week. The gears and spirals should be greased once every six months.

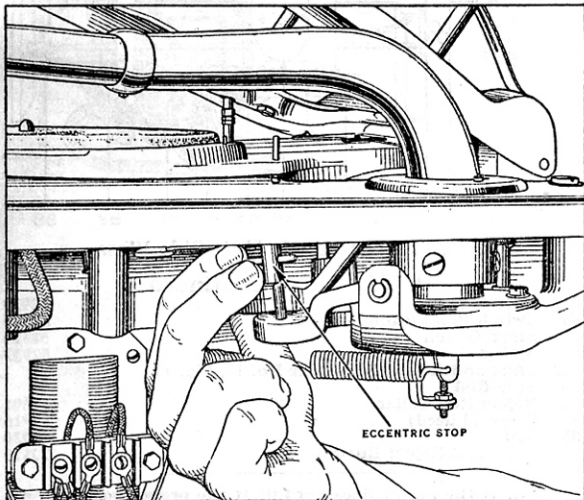
Fig. 13—Adjusting 12" Eccentric Stop

**12. NEEDLE LOWERS OUTSIDE 12" RECORD DIAMETER**—Should the needle fail to lower on the smooth outside rim of a 12" record, but lowers outside the record:

- a. Loosen the clamping screw for the eccentric screw, 32, Fig. 1, in the taper tube arm casting with a short screw driver.
- b. With a small rod or nail turn the eccentric adjustment as shown in Fig. 13.
- c. Check the setting after successive trials until the proper position is obtained, and then re-tighten the clamping screw securely.

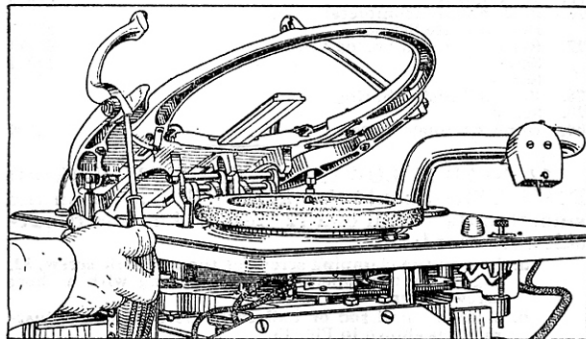
Fig. 10—Adjusting Hopper Arm Screws

- a. Records are improperly loaded. (See Subject 2 under GENERAL).
- b. Hopper improperly adjusted with respect to lift ring. See b of subject 6 above.
- c. Hopper arm improperly aligned, allowing the two bottom records to pass under the arms. Lower the hopper arms by turning the small adjusting screws as shown in Fig. 10, so that both hopper arm spacers touch the lift ring when the latter is in its raised position and there are no records in the hopper. Spacing for gates on hopper arms should be between .093" and .107".

7. Lift ring spring adjusting nuts	Adjusting tension of lift ring spring	No. 69, Fig. 11
8. Hopper arm adjusting screws	Adjusting hopper arms onto front of lift ring	Fig. 10
